# CONDITION SURVEY, LOCKBOURNE AIR FORCE BASE, OHIO

R. D. Jackson

June 1973

Contracted by U. S. Army Engineer Waterways Experiment Station  
Soils and Pavements Laboratory  
Vicksburg, Mississippi

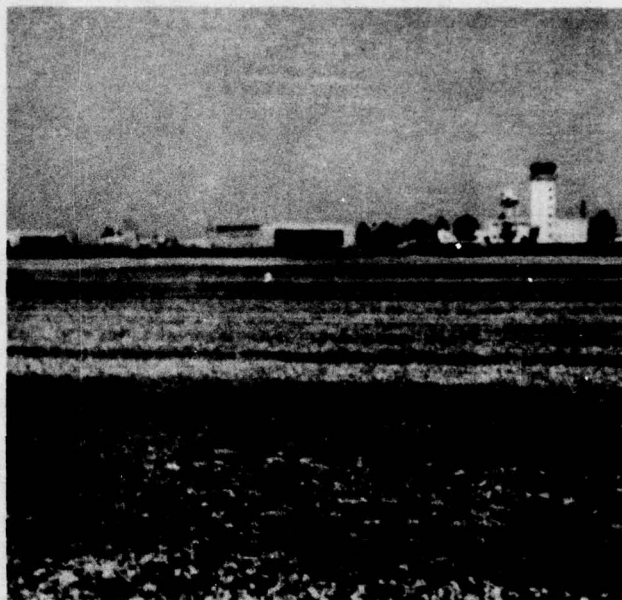
12. NE-SW runway 2 was in excellent condition based on the percentage of slabs containing no major defects. The first 1000 ft of the NE end (features R1A and R2B) contained only 3 major defects. The first 1000 ft of the SW end (features R1A and R2B) contained only 14 major defects. Feature R3C (the interior portion of the runway) contained 66 major defects. The entire runway contained 395 corner spalls that had resulted from "D" cracking\*\*. Practically all slabs on the runway contained "D" cracking to some degree. NE-SW runway 1 was in generally poor condition; however, the portland cement concrete (PCC) ends were in very good condition. The interior portion, which is 8-in. PCC overlayed with 6 in. of AC, was in poor condition. As a result of continued deterioration and expansion of the underlying PCC pavement along the slab joints, both longitudinal and transverse blowups have occurred (see photos 1-3). At the time of this survey, NE-SW runway 1 was closed.

Photo 1. View of NE-SW runway 1 between taxiways C and D

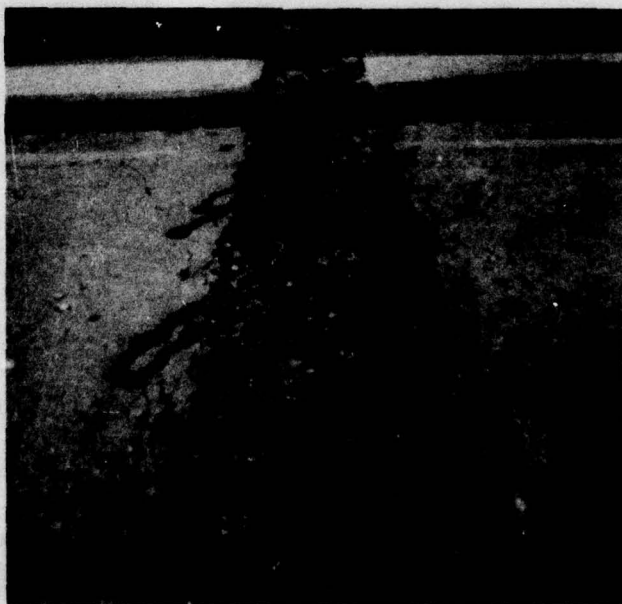
Photo 2. Poor joint in NE-SW runway 1, north of taxiway E

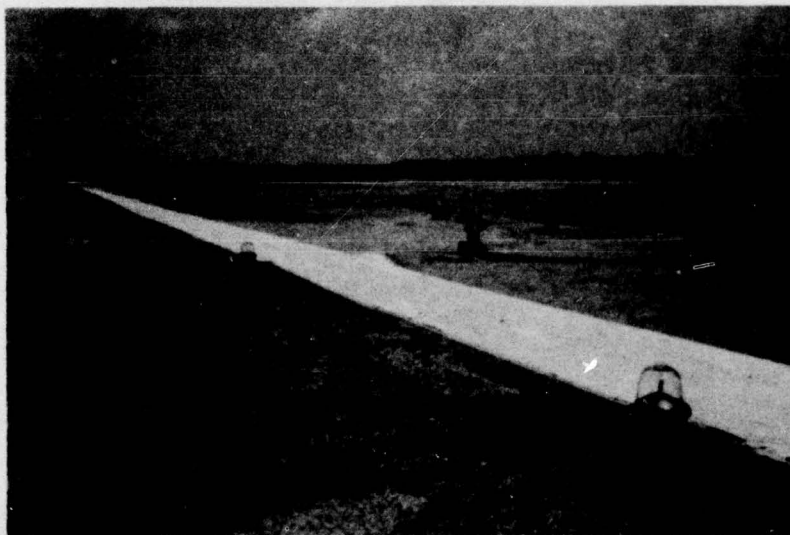
- a. Intersection of taxiway C and NE-SW runway 1. About 100 ft of the runway pavement (6-in. AC over 8-in. PCC on a 6-in. gravel base) had heaved about 4 or 5 in. in a pattern following the underlying PCC pavement joints. This blowup resulted from the expansion of the rigid pavement. Water was flowing onto the pavement surface from one of the joints. (See photos 7 and 8.)
- b. NE-SW runway 1, between taxiway C and sta 70+79. The junction between the rigid pavement and the flexible shoulder on the northeast side showed water stains.
- c. NE-SW runway 1 (3-in. AC over 11-in. PCC on a clay subgrade), between sta 70+79 and 95+00. There was evidence of bleeding joints.
- d. NE parking apron (12-in. PCC on a clay subgrade). This apron had been abandoned because of extensive blowups and spalling. There was also evidence of bleeding joints in this area.

Photo 7. Blowup at intersection of taxiway C  
and NE-SW runway 1

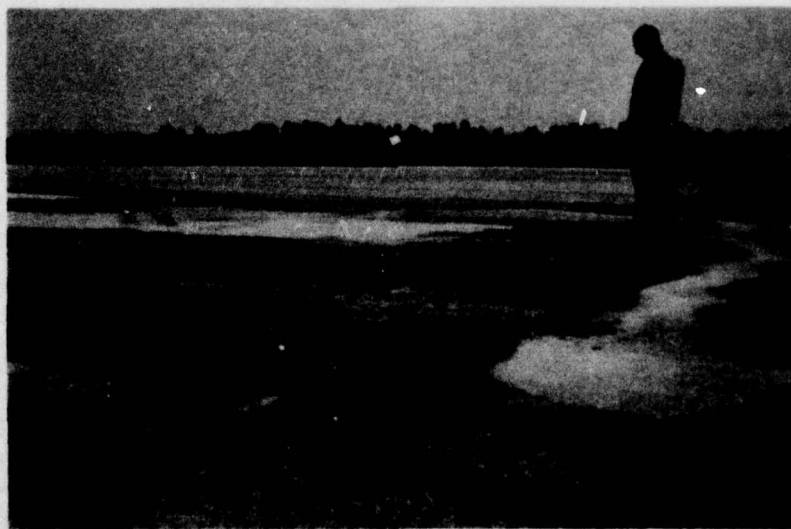
Photo 8. Water flowing from joint at intersection  
of taxiway C and NE-SW runway 1
